NBS BUILDING SCIENCE SERIES 77

# Acoustical and Thermal Performance of Exterior Residential Walls, Doors and Windows

*1105*  
Hale J. Sabine and Myron B. Lacher

Daniel R. Flynn and Thomas L. Quindry

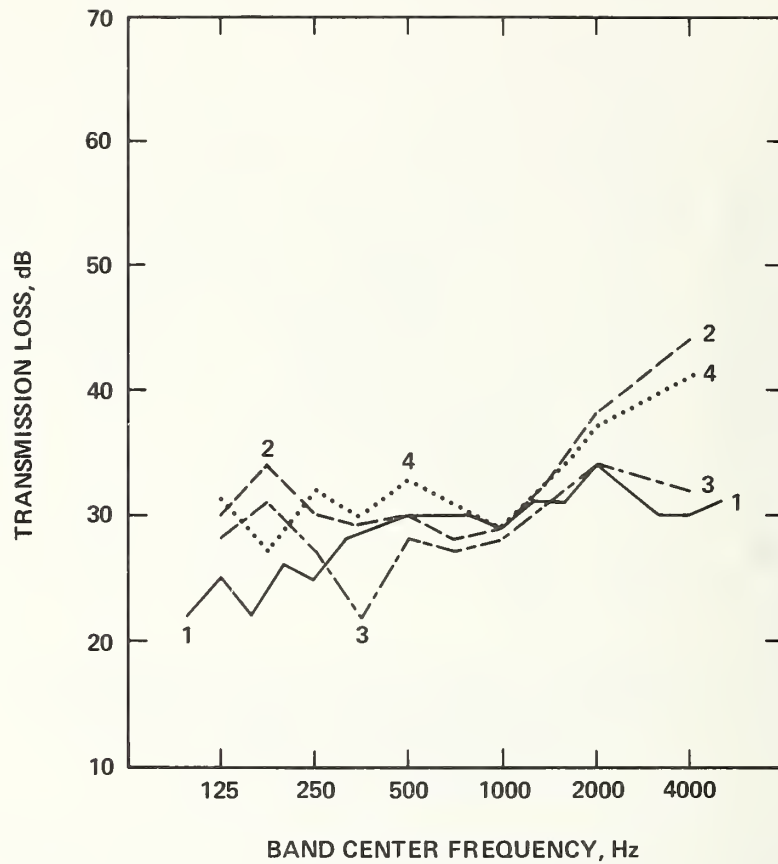
Figure 46. Sound transmission loss vs frequency data for solid core wood doors.

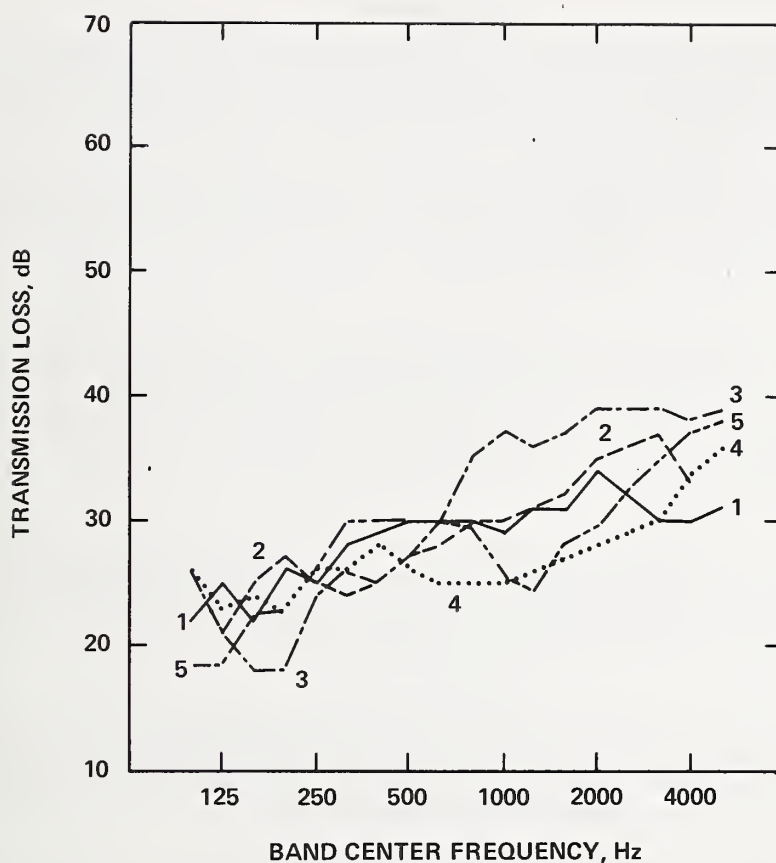
Figure 47. Sound transmission loss vs frequency data for solid core wood doors. Curve 1 is the same as in Figure 46.

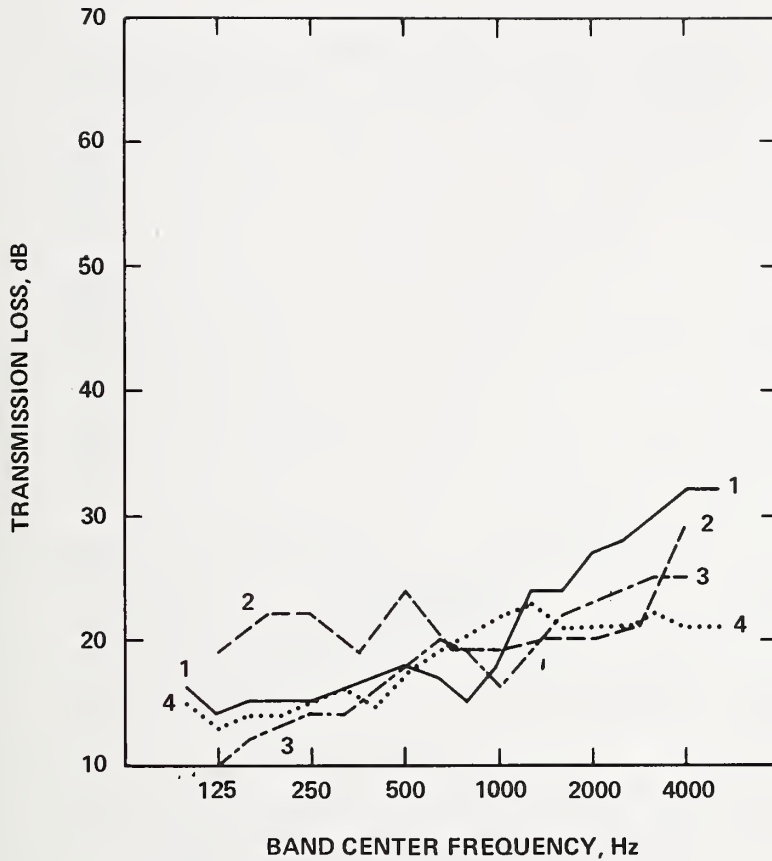
Figure 48. Sound transmission loss vs frequency data for hollow core wood cores.

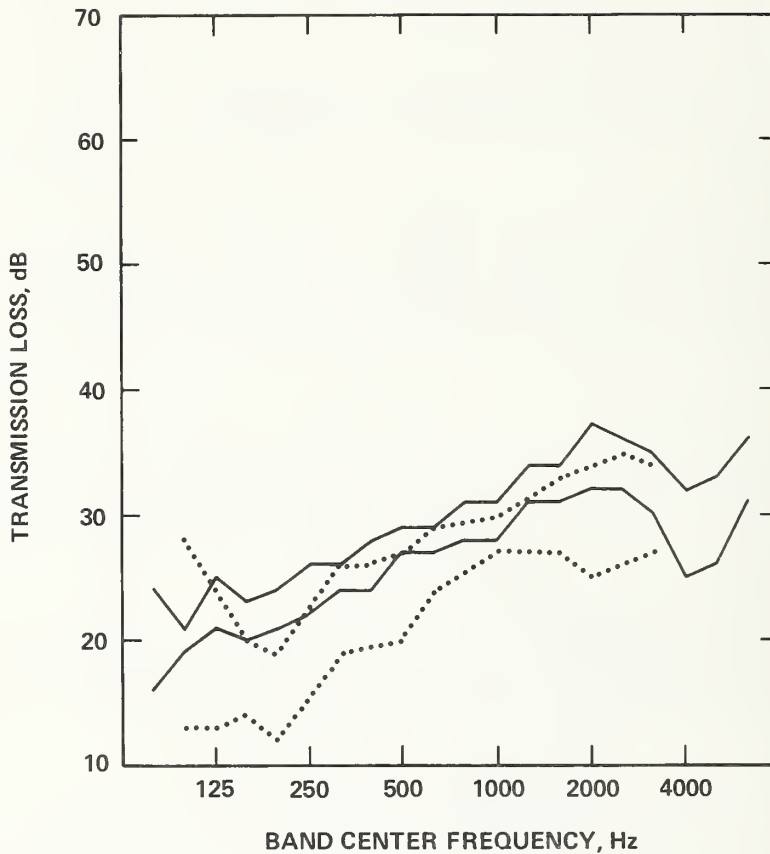
Figure 49. Sound transmission loss vs frequency data for sealed windows, of various types and sizes, with double-strength (3 mm) glazing. The solid curves represent the envelope of data obtained in the present investigation (Tests W-7-71, W-32-71, W-34-71, W-64-71, W-66-71, and W-21-72). The dotted curves represent the envelope of data, on sealed windows only, from Table A5 of Marsh [63] (the sets of data included are the 2nd and 3rd of Aston, the 1st of Wooley, and the 1st, 2nd and 4th of Saint-Gobain).

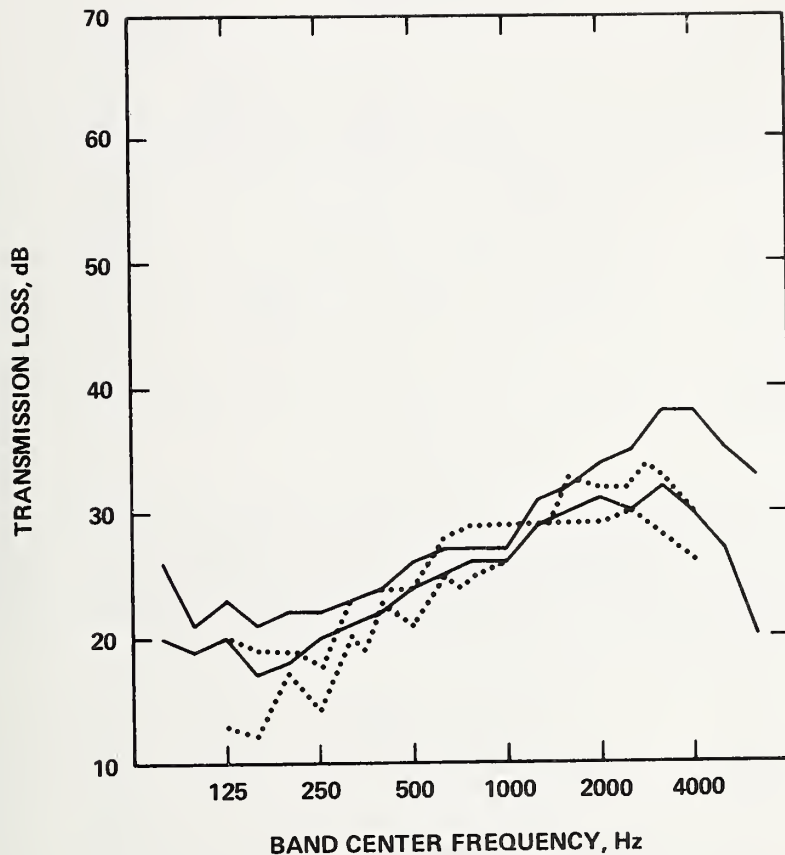
Figure 50. Sound transmission loss vs frequency data for sealed windows, of various types and sizes, with single-strength glazing. The solid curves represent the envelope of data obtained in the present investigation (Tests W-8-71, W-33-71, W-41-71, W-76-71, and W-26-72). The dotted curves represent the envelope of the following data: Brandt (2 mm glass) and Libbey-Owens-Ford (3/32 in. glass) from Table A6 of Marsh [63]; caulked steel frame casement window (3/32 in. glass) from Bishop and Hirtle [62].

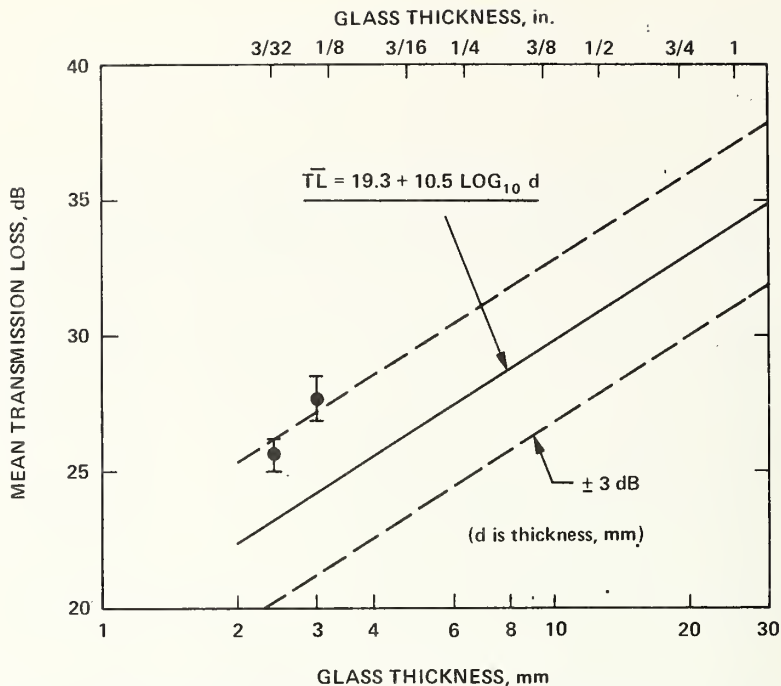
Figure 51. Mean sound transmission loss (arithmetic average of the values over the range 100 to 3150 Hz) of sealed windows vs glass thickness. The solid line is that which was fitted to literature data by Marsh [63]. The dashed lines enclose all but two of the data points she used to derive the solid line. The solid circles represent the average and range of data on single- and double-strength glazing from the present investigation.

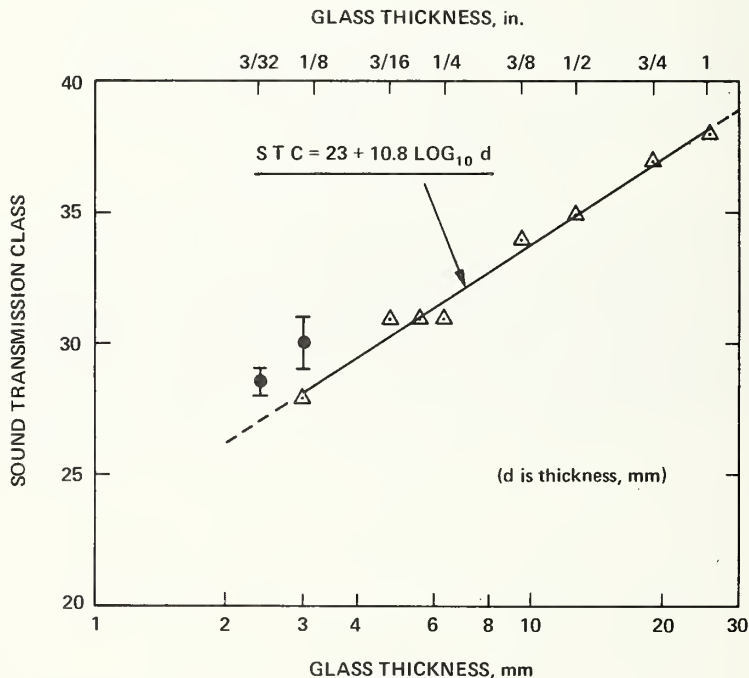
Figure 52. Sound Transmission Class of sealed windows vs glass thickness. The triangles and the line fitted through them represent the data reported by Patil [64]. The solid circles represent the average and range of data on single- and double-strength glazing from the present investigation.

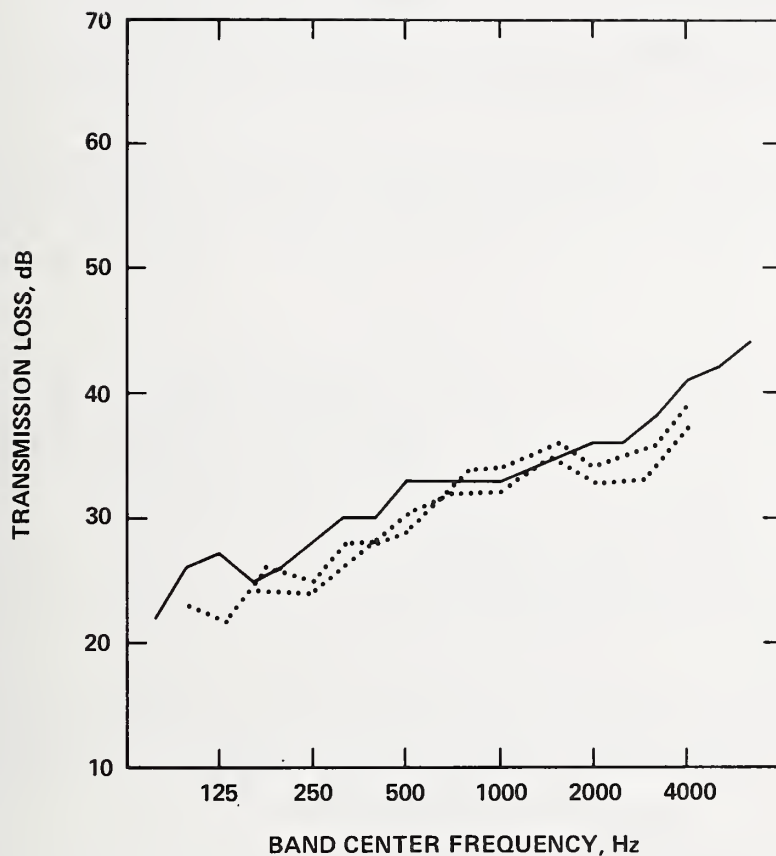
Figure 53. Sound transmission loss vs frequency data for 1/4 in. laminated glass with an internal damping layer. The solid curve represents the data from the present investigation (Test No. W-22-72) while the dotted curves represent the envelope of data from Table A8 of Marsh [63] (the two sets of data are that of Pilkington Bros. and the 1st of Libbey-Owens-Ford).

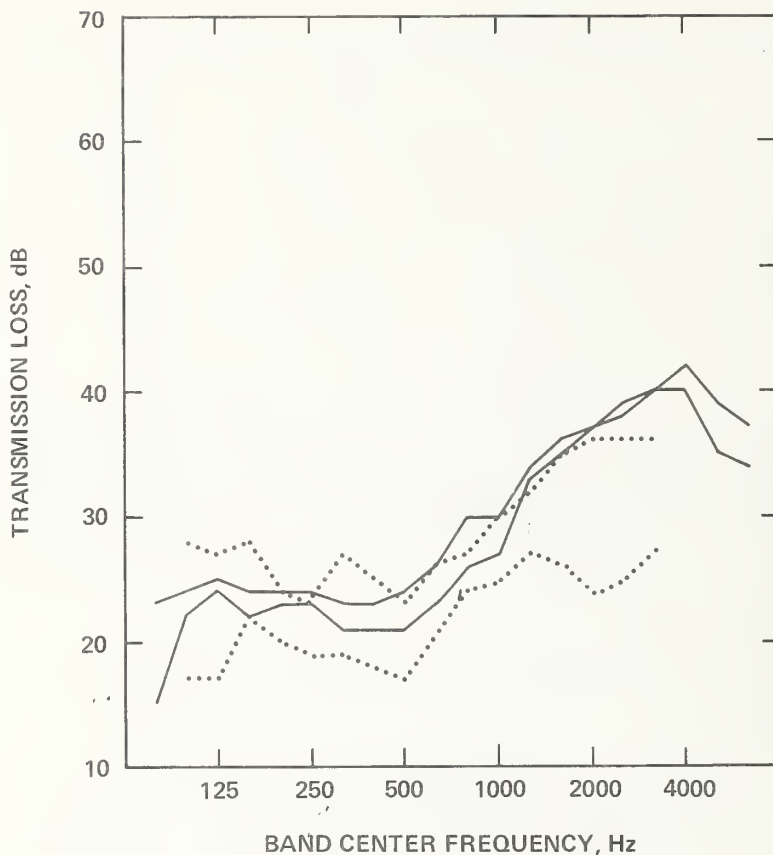
Figure 54. Sound transmission loss vs frequency data for 7/16 in. insulating glass units consisting, nominally, of two 1/8 in. panes of glass separated by a 3/16 in. air space. The solid curves represent the envelope of data obtained in the present investigation (Tests W-31-71 and W-29-72). The dotted curves represent the envelope of data from Table B1 of Marsh [63]. (the sets of data included are the 2nd of Wooley and the two of Saint-Gobain).

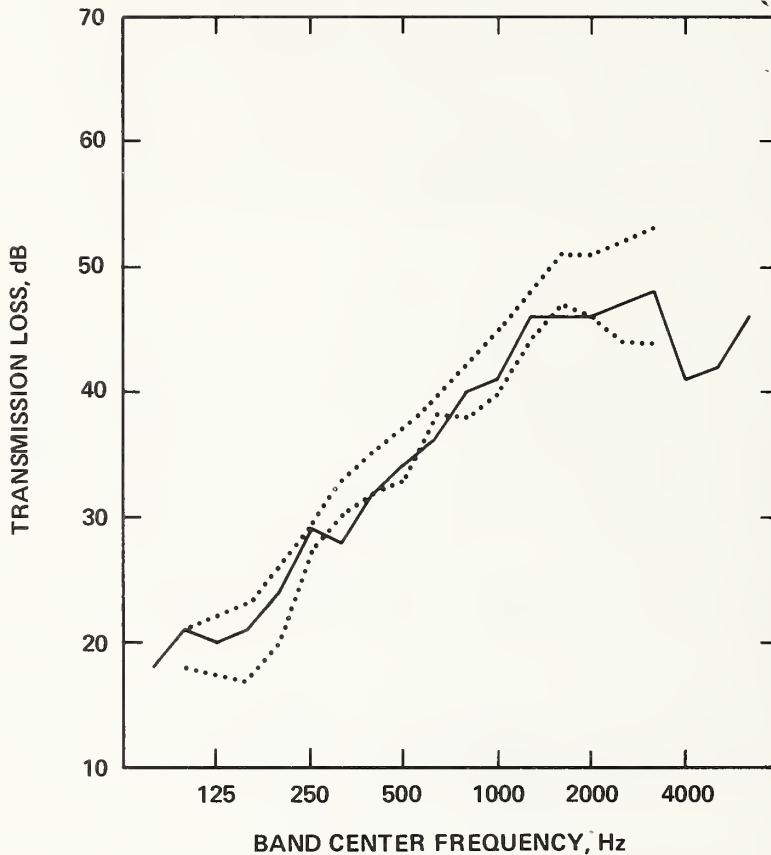
Figure 55. Sound transmission loss vs frequency data for double glazing with a nominal 4 in. separation between the two panes. The solid curve represents a 6 x 5 ft picture window glazed single strength (2.4 mm) with a double strength (3mm) storm window spaced 95 mm (3 3/4 in.) away (Test W-11-71). The dotted curves represent the envelope of data, from Table C2 of Marsh [63], for 3 mm panes separated by 100 to 102 mm (the sets of data are the first listed for each of the following: Aston, Ingemansson, and Woolley).

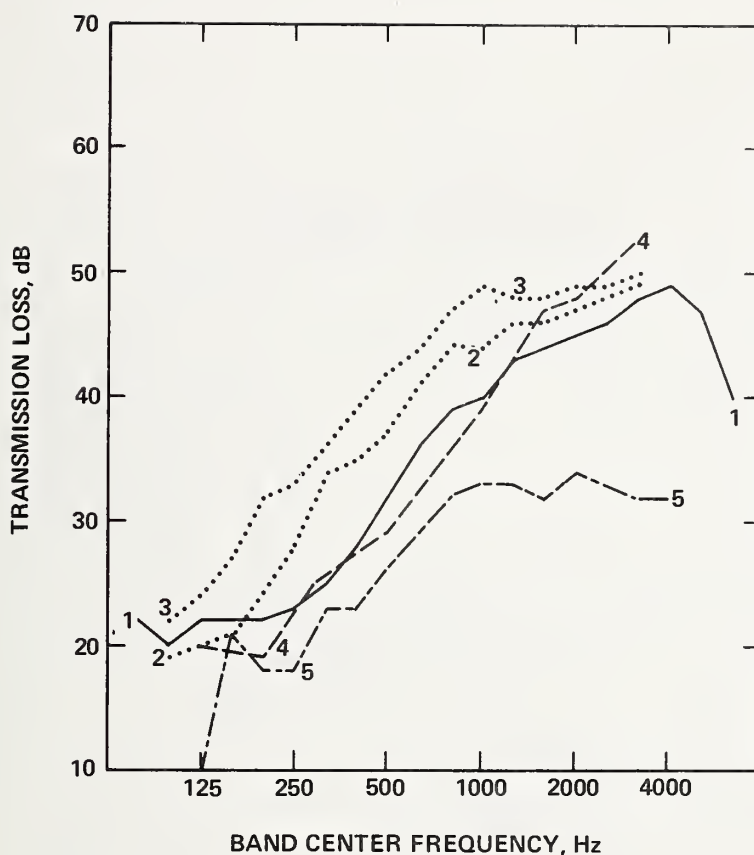
Figure 56. Sound transmission loss vs frequency data for double glazing with an average nominal spacing of about 2 to 3 in. between the two panes.

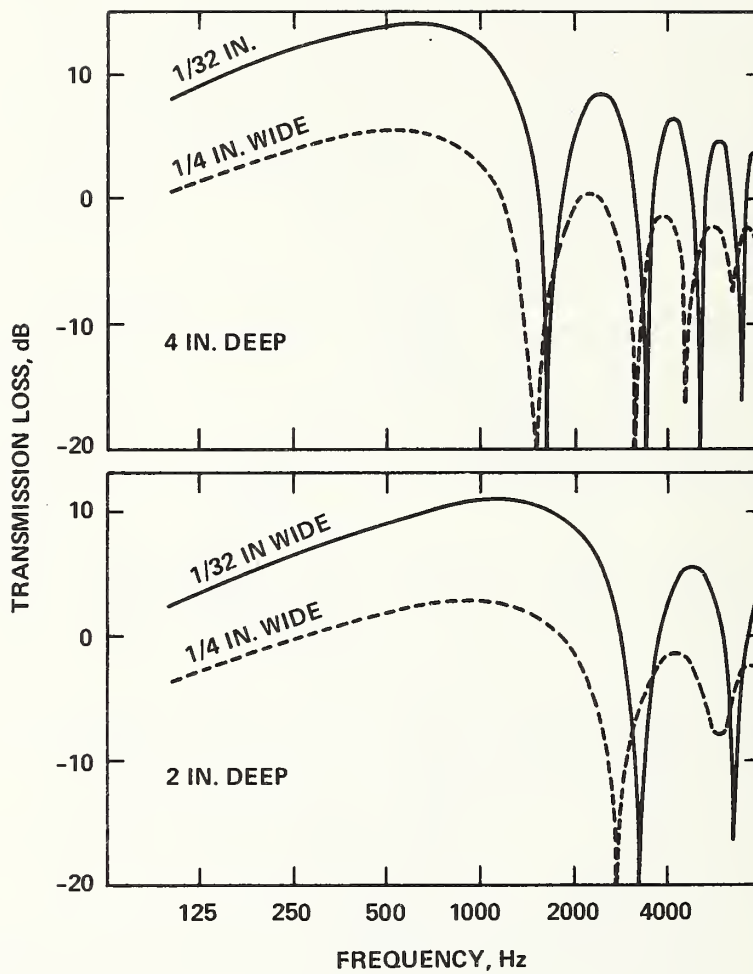
Figure 57. Theoretical sound transmission loss vs frequency data for slits in the middle of a wall between two reverberant rooms, as computed from eq. (69) of Gomperts [76].

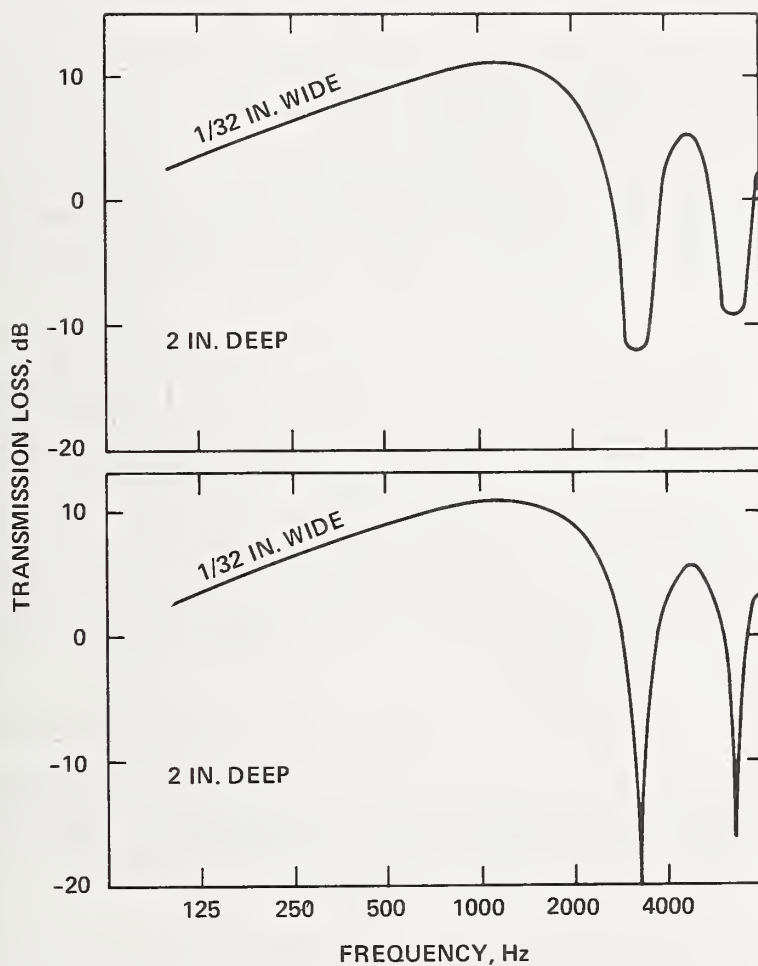
Figure 58. Theoretical sound transmission loss vs frequency data for slits in the middle of a wall between two reverberant rooms. The lower curve represents pure tone behavior while the upper curve corresponds to values averaged over a frequency band that is  $1/3$  octave in width. The lower curve was computed from eq. (69) of Gomperts [76] while the upper curve was derived by numerical integration of the transmission coefficient corresponding to the lower curve.

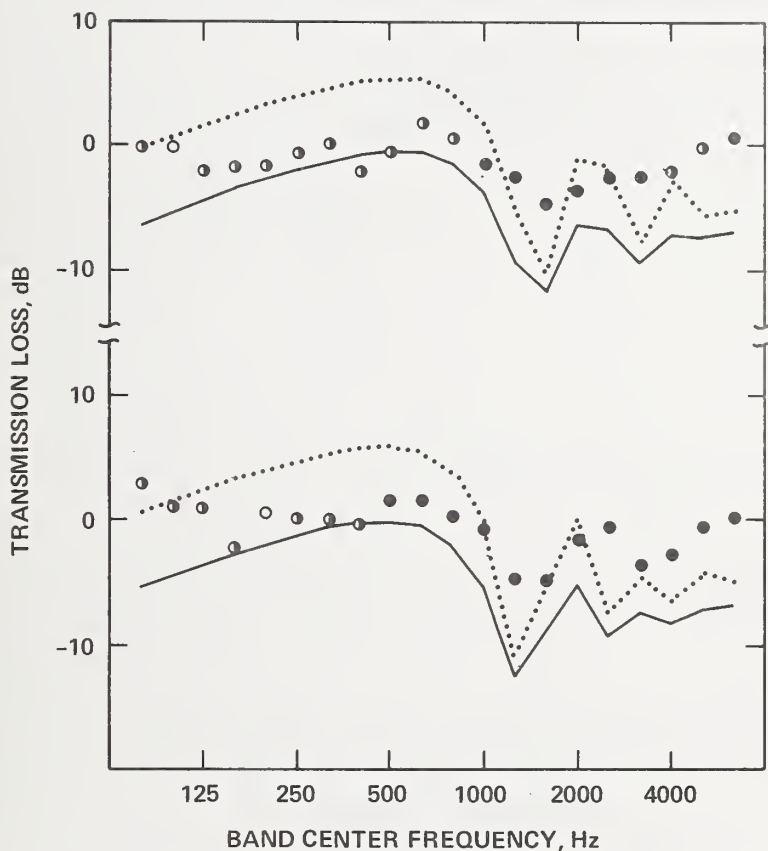
Figure 59. Comparison of experimental results and theoretical predictions for the sound transmission loss of 1/4 in. cracks around picture windows. The data points in the upper portion of the figure are from Test W-16-71 and the average of Tests W-7-71 and W-9-71; those in the lower portion are from Tests W-12-71 and W-10-71. Solid symbols indicate that the transmission loss of the sealed window was at least 9 dB greater than that of the leaky window, while half-filled symbols indicate a 6 to 9 dB difference and open symbols a 3 to 6 dB difference. If the effect of the crack was less than 3 dB for a given frequency band, the data are not plotted. The dotted curves were calculated from equation (69) of Gomperts [76] averaged over a 1/3 octave band, for a slit in the middle of a wall; the solid curves were calculated in a similar manner but correspond to a slit at the edge of a wall between two reverberant rooms. The effective depth of the slit was taken as 4.5 in. for the theoretical calculations in the lower figure and as 4.0 in. for those in the upper figure.

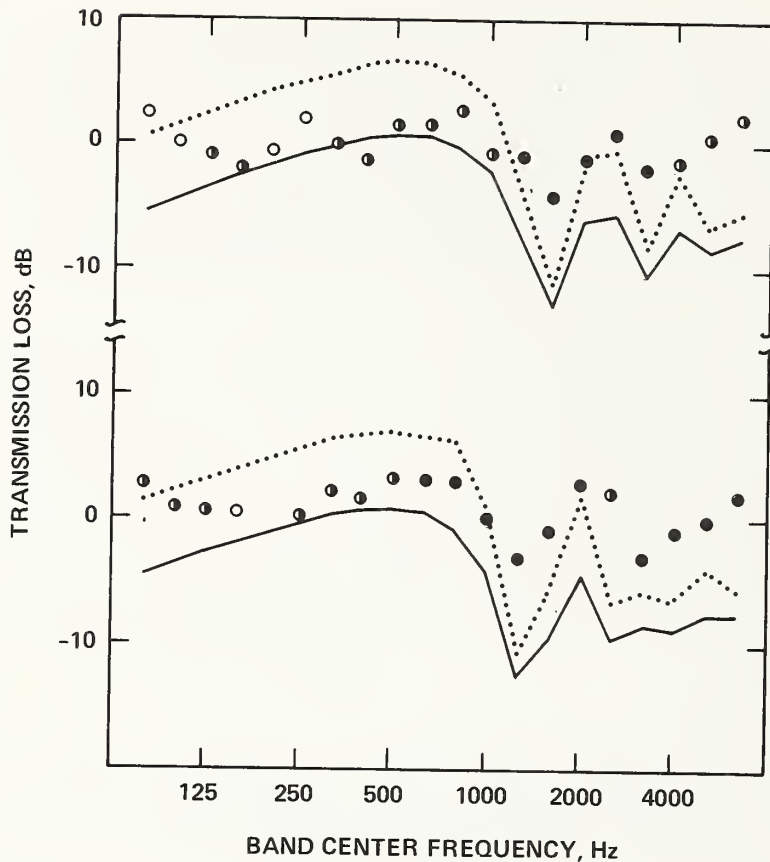
Figure 60. Comparison of experimental results and theoretical predictions for the sound transmission loss of 1/8 in. cracks around picture windows. The data points in the upper portion of the figure are from Test W-15-71 and the average of Tests W-7-71 and W-9-71; those in the lower portion are from Tests W-18-71 and W-10-71. The effective width of the slit was taken as the uniform width which would contain the same mass of air as the actual slit (which consisted of two segments of different widths. (Otherwise, as in Figure 59).

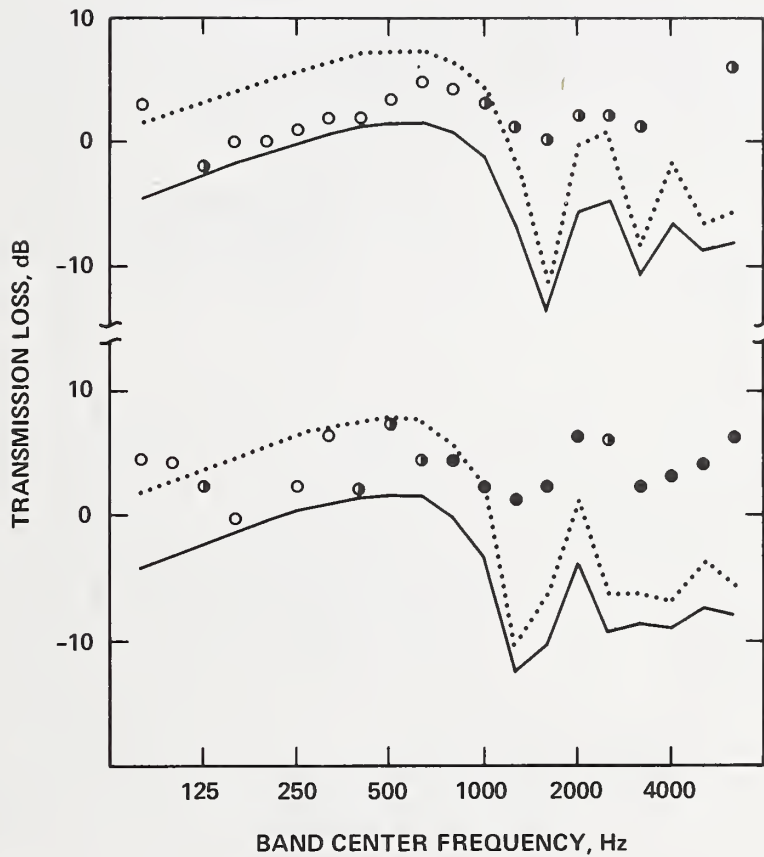
Figure 61. Comparison of experimental results and theoretical predictions for the sound transmission loss of 1/16 in. cracks around picture windows. The data points in the upper portion of the figure are from Test W-17-71 and the average of Tests W-7-71 and W-9-71; those in the lower portion are from Tests W-18-71 and W-10-71 (Otherwise, as in Figure 60).

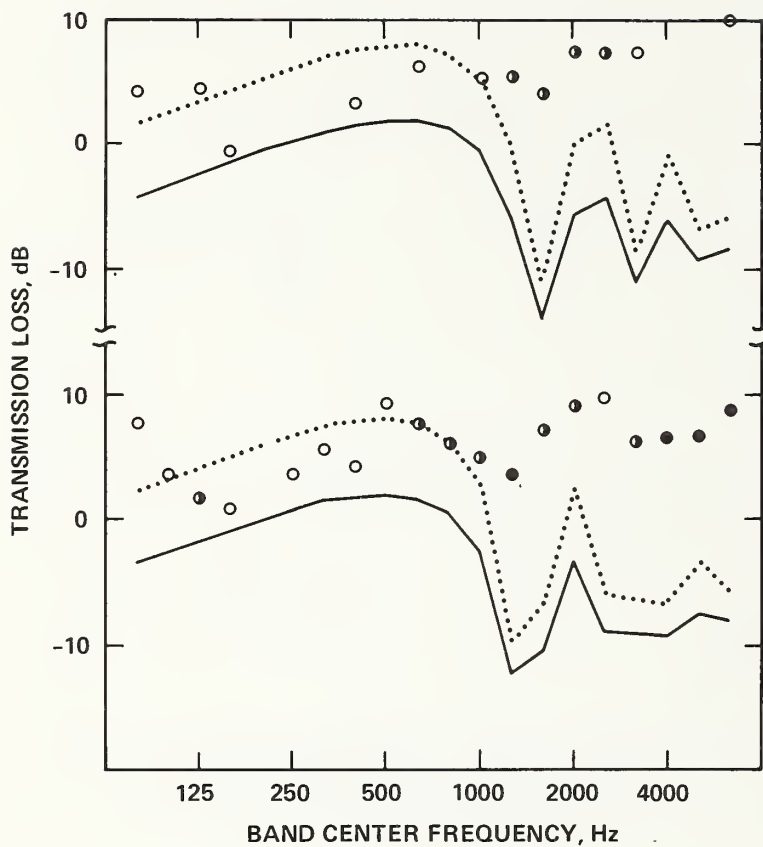
Figure 62. Comparison of experimental results and theoretical predictions for the sound transmission loss of 1/32 in. cracks around picture windows. The data points in the upper portion of the figure are from Test W-21-71 and the average of Tests W-7-71 and W-9-71; those in the lower portion are from Tests W-19-71 and W-10-71. (Otherwise, as in Figure 60).

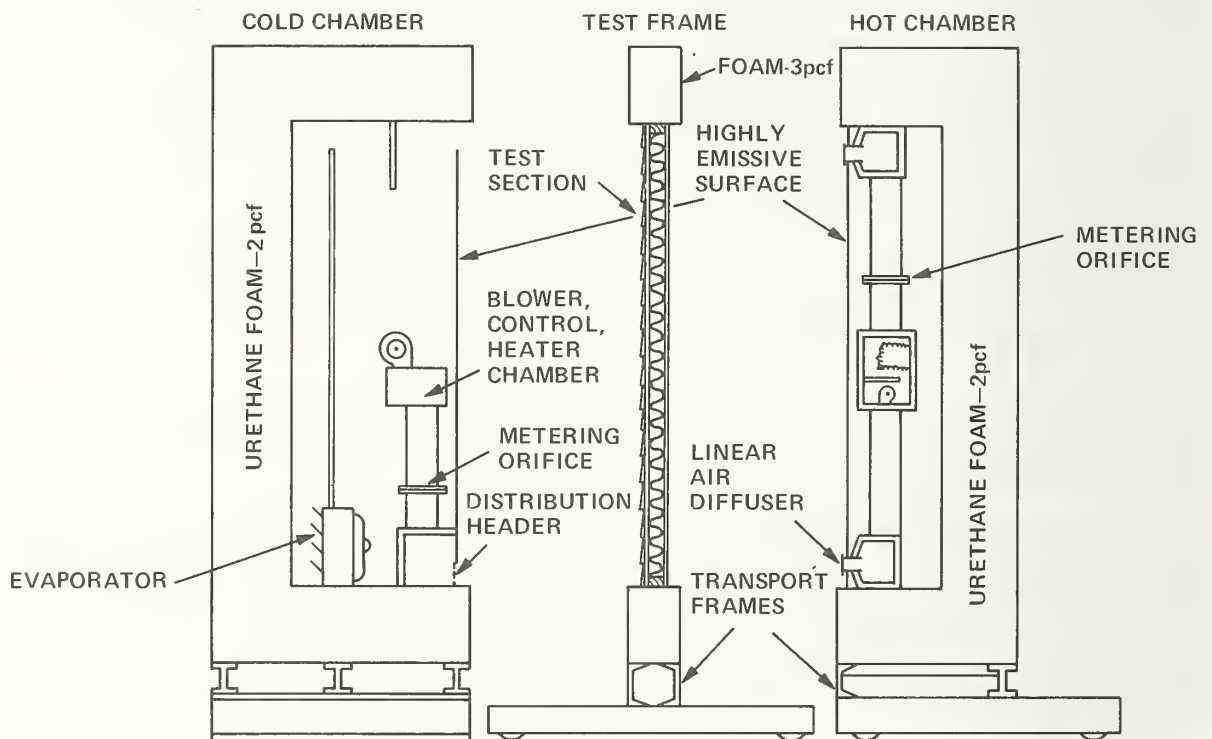
Figure 63. Schematic section of calibrated hot box facility used for thermal tests. Components are described in the text and by Mumaw [119].

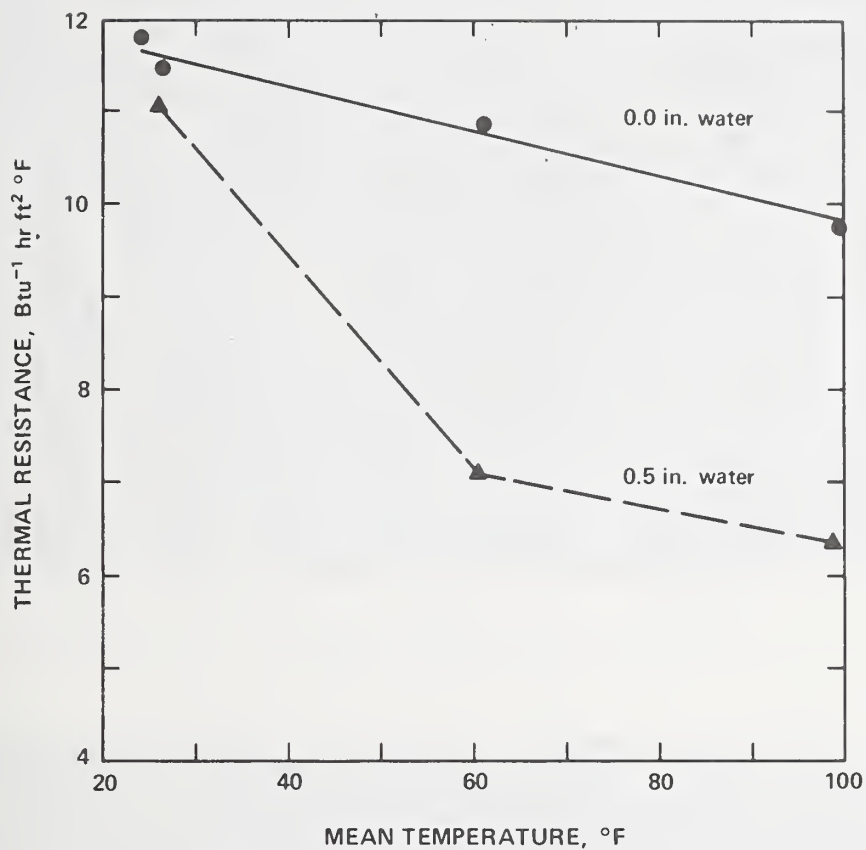
Figure 64. Thermal resistance vs mean temperature data for a 2 x 4 in. stud wall with 1/2 in. gypsum board on the interior surface, redwood lap siding over 1/2 in. wood fiber sheathing on the exterior surface, and 3 1/2 in. Fiberglas Friction Fit Building Insulation plus a polyethylene vapor barrier in the cavity.

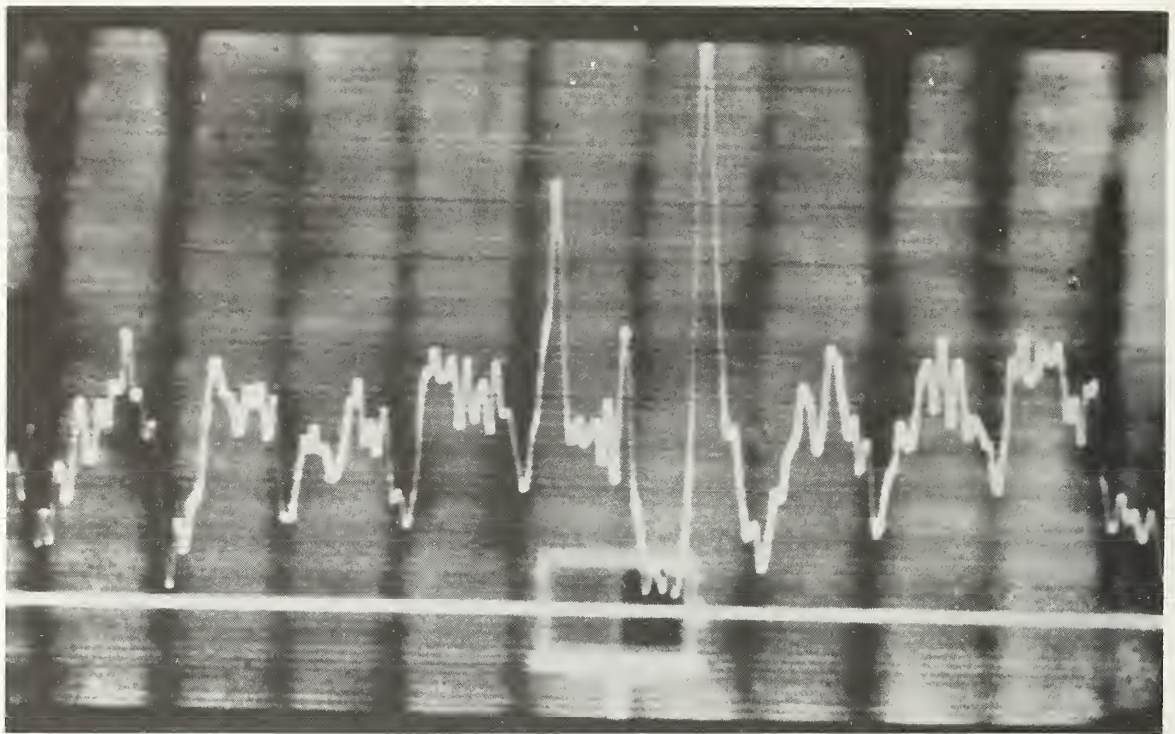
Figure 65. Infrared thermograph of warm side of wall insulated with 3 1/2 in. Fiberglas Friction Fit Insulation. Comparator temperature difference: 2.1 °F.

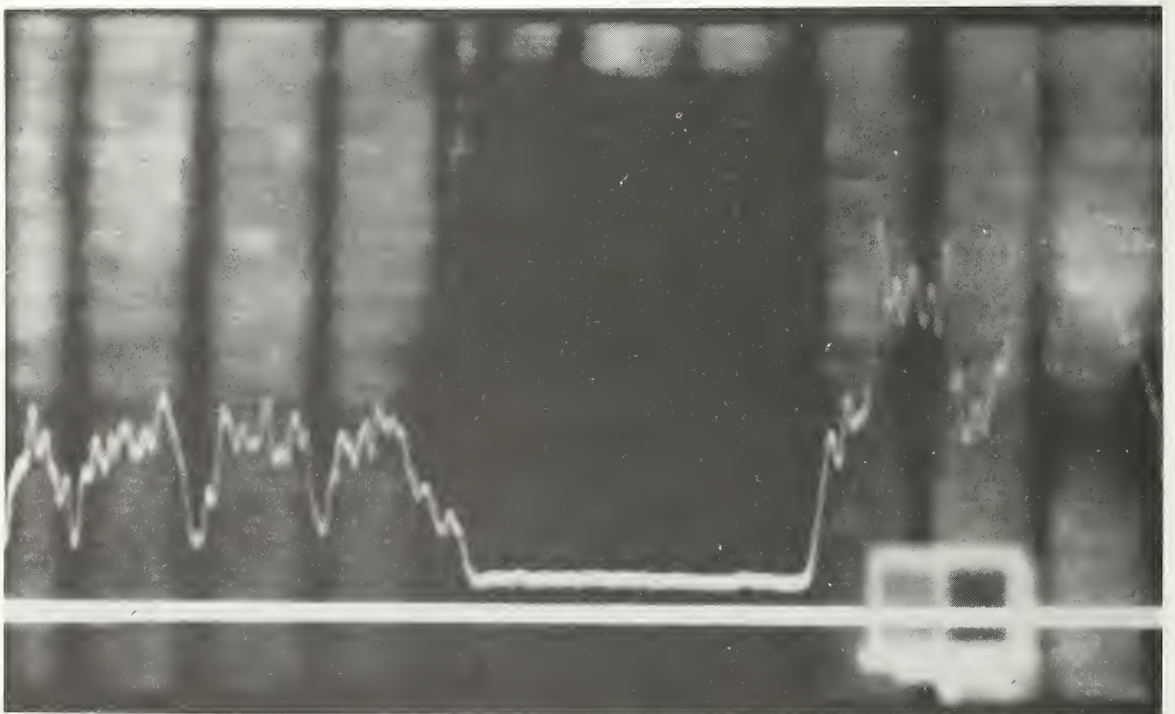
Figure 66. Infrared thermograph of warm side of wall insulated with 3 1/2 in. Fiberglas Friction Fit Insulation, penetrated by a double-hung wood window, 3 x 5 ft, single-glazed, locked. Comparator temperature difference: 2.0 °F.

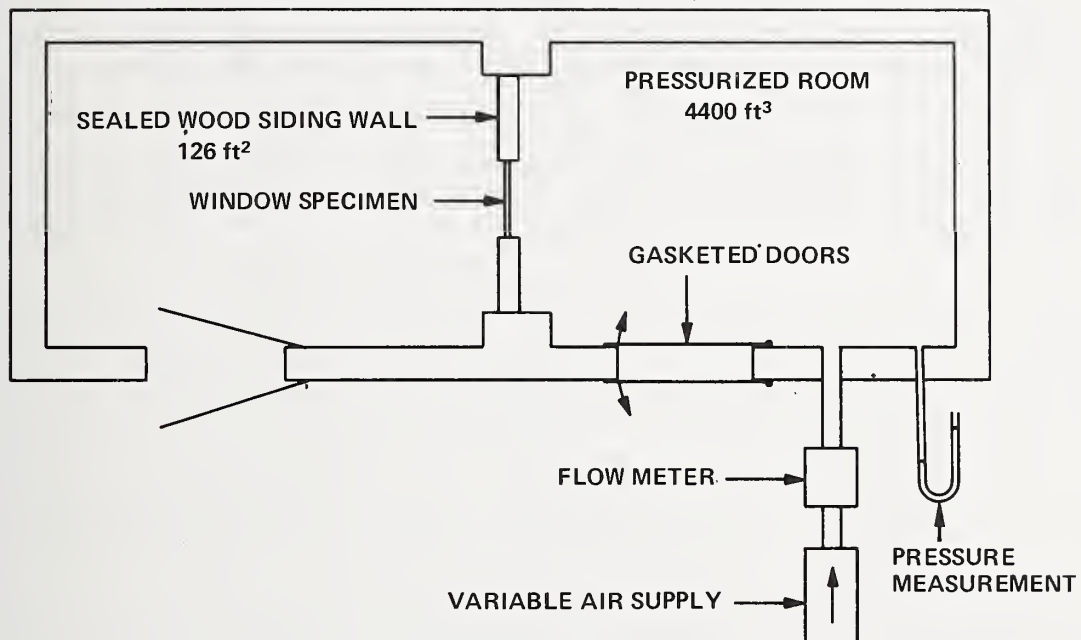
Figure 67. Experimental setup for measuring air filtration of doors and windows in the sound transmission facility.

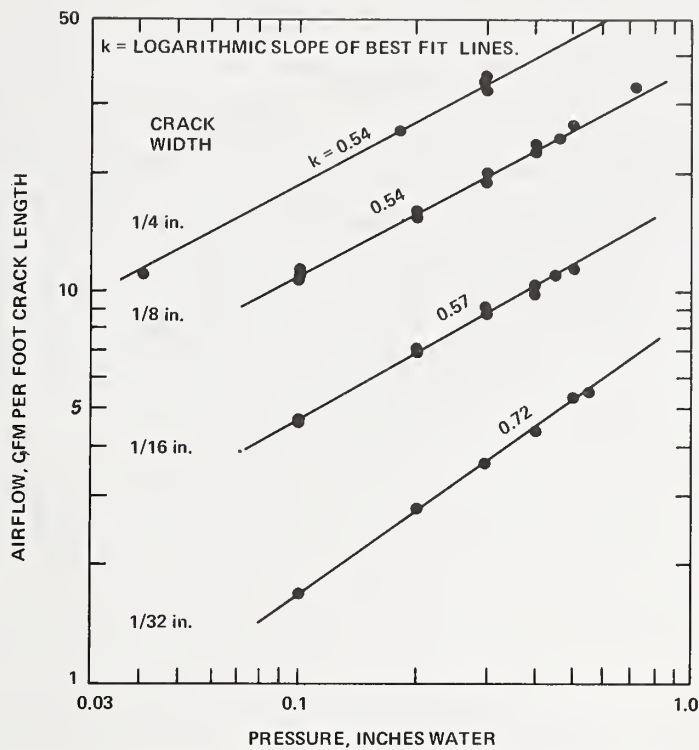
Figure 68. Air infiltration through gauged cracks around picture window. Multiple points at the same pressure and crack width represent crack lengths varying from 2 to 20 ft.

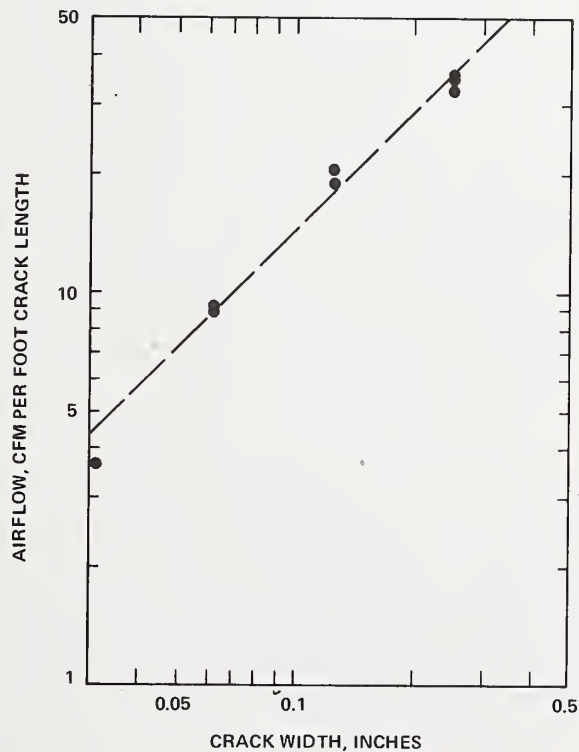
Figure 69. Air infiltration, as a function of crack width, through gauged cracks around picture window at 0.3 in. water pressure.

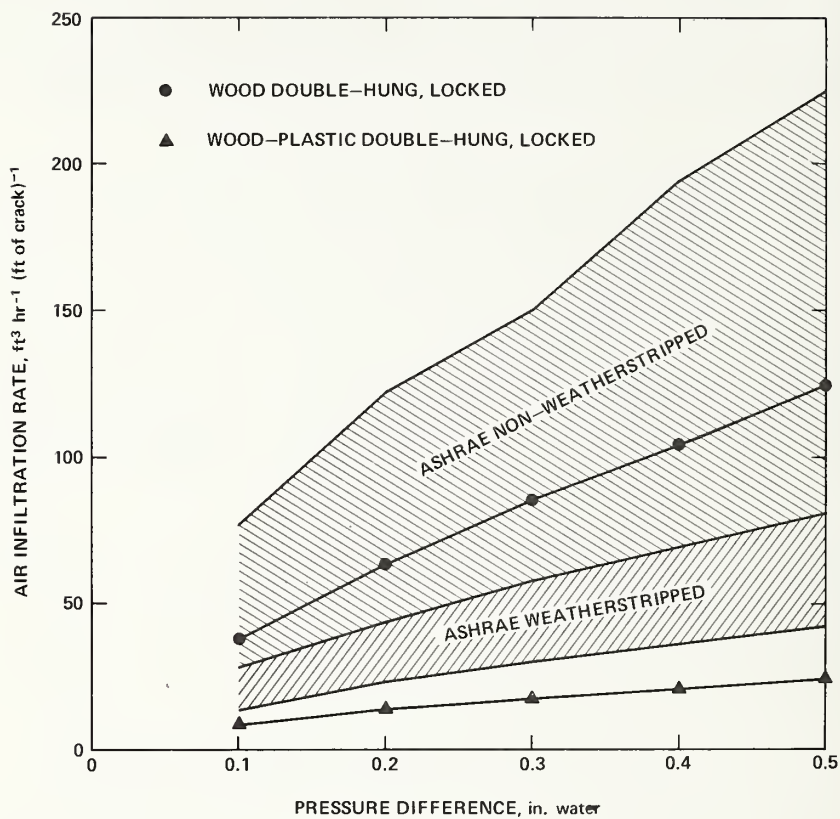
Figure 70. Air infiltration, per foot of crack, for locked wood (Test W-24-71) and wood-plastic (Test W-74-71) double-hung windows compared with ASHRAE design values.

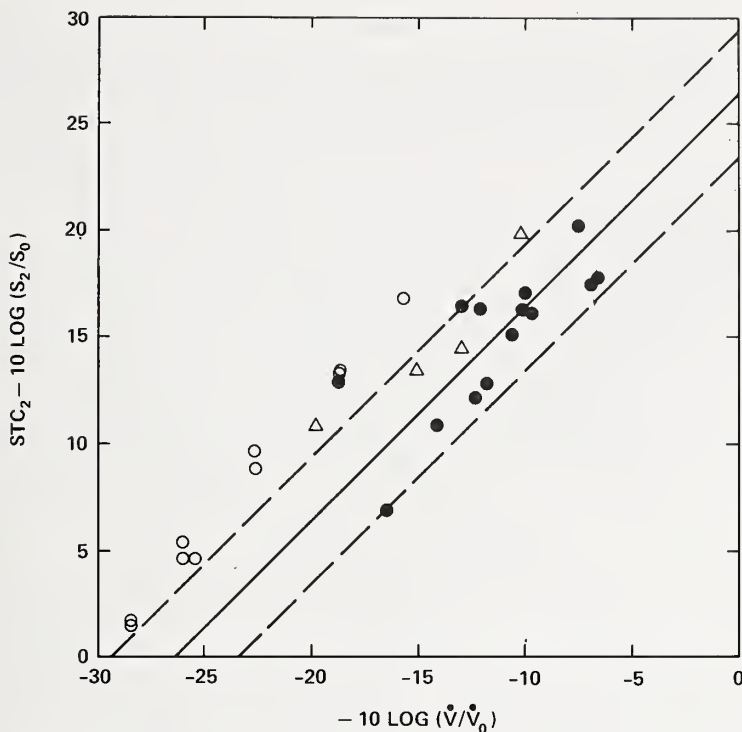
Figure 71. Experimentally determined values for  $STC_2 - 10 \log (S_2/S_0)$  plotted vs experimentally determined values for  $-10 \log (\dot{V}/\dot{V}_0)$ ; see text.

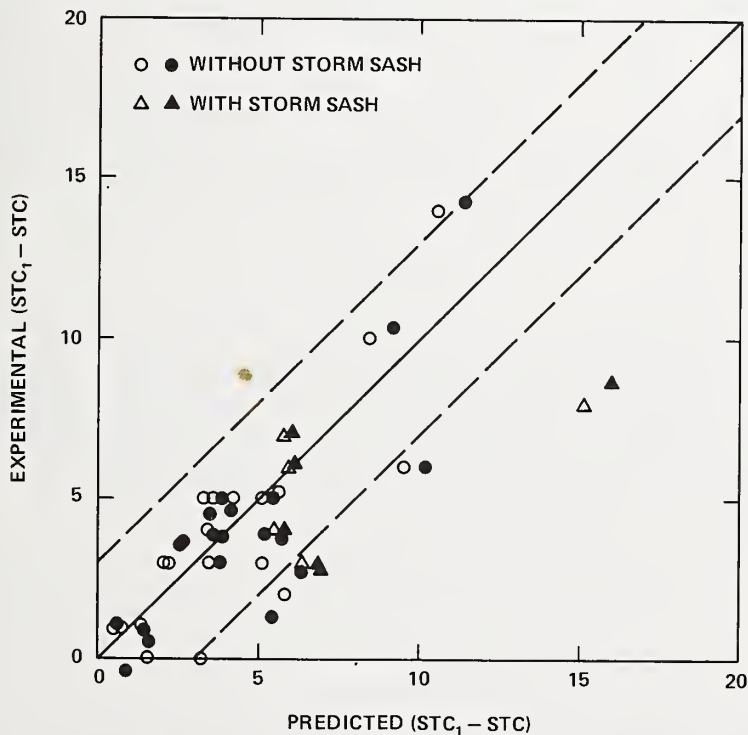
Figure 72. Experimental values for the decrease in sound transmission loss due to leaks around windows or doors versus values predicted using equation (22). The open symbols represent conventional calculations [22] of the Sound Transmission Class. Closed symbols correspond to STC-values computed exactly (rather than to the next lowest decibel) and without invoking the "-8 dB rule".

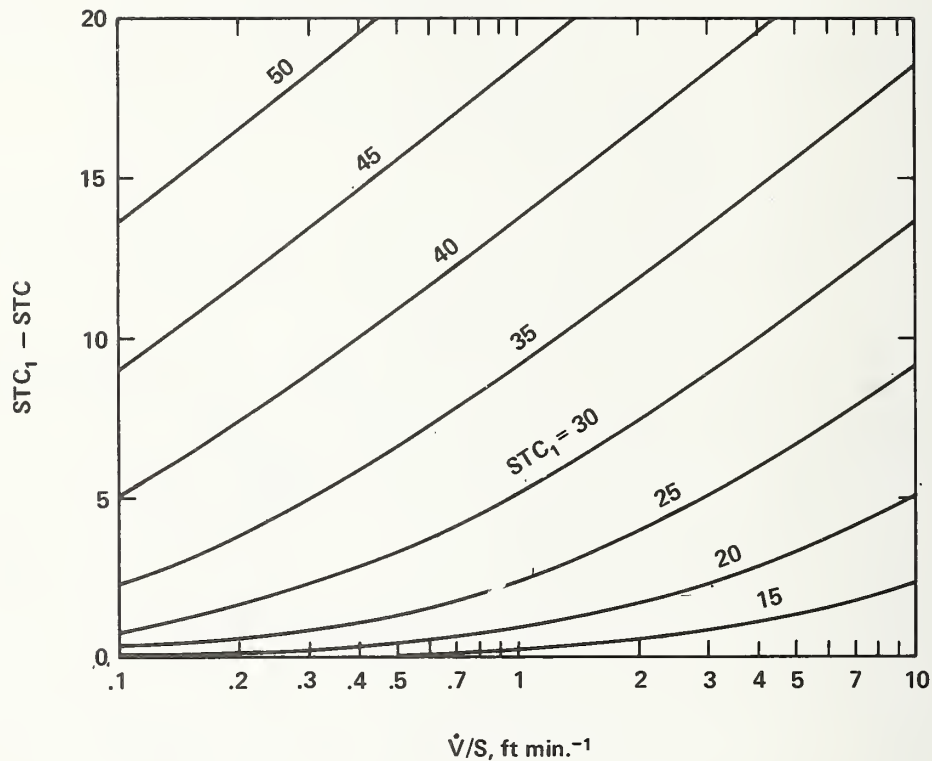
Figure 73. Expected decrease in Sound Transmission Class as a function of air leakage rate divided by area. The air leakage rate,  $\dot{V}$ , measured according to ASTM E283-73 [125] is expressed in scfm at a pressure difference of 0.3 in. water. The window or door area,  $S$ , is in sq ft. The parameter on the curves is the Sound Transmission Class of the sealed unit (window or door).

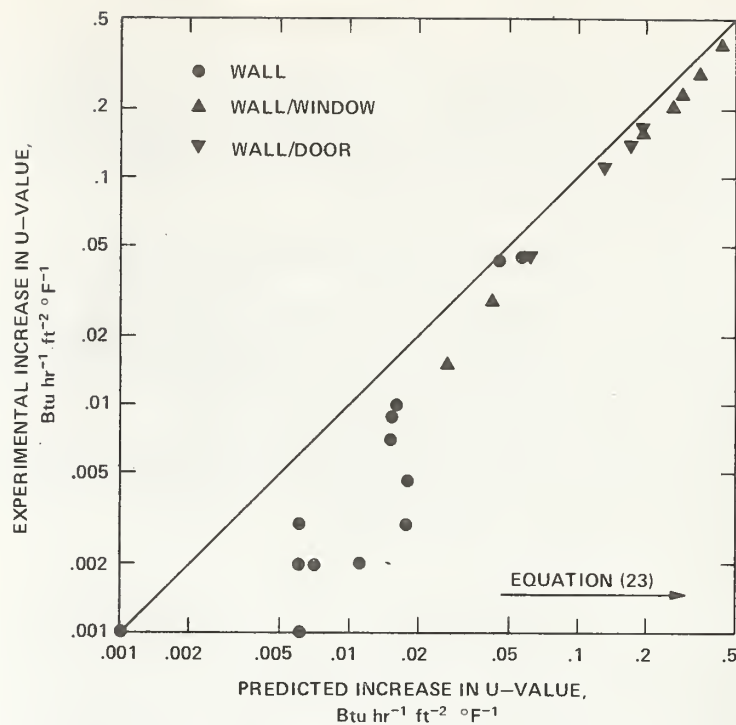
Figure 74. Experimentally observed increase in effective thermal transmittance of 9 x 14 ft walls, with and without penetrating doors or windows, vs the increase predicted by equation (23). The scatter for small values of thermal transmittance arises from imprecisions in both the thermal transmittance data and the air flow rate data (used in equation (23)).

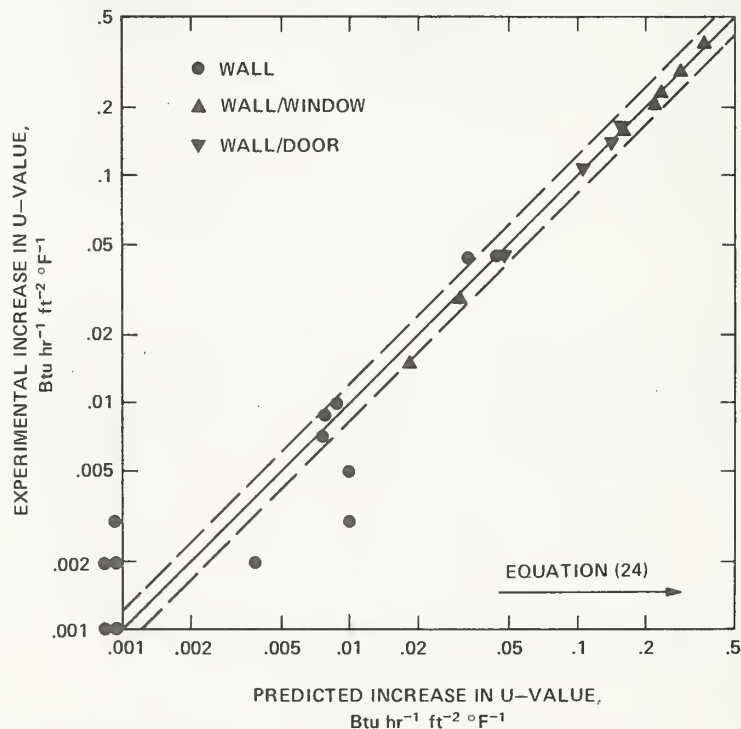
Figure 75. Experimentally observed increase in effective thermal transmittance of 9 x 14 ft walls, with and without penetrating doors or windows, vs the increase predicted by equation (24). The data points shown just to the left of the left-hand ordinate correspond to predicted values below the range of the abscissa (cf. corresponding points in Figure (74)). The dashed lines bound the region  $\pm 20$  percent around the line of perfect concordance.

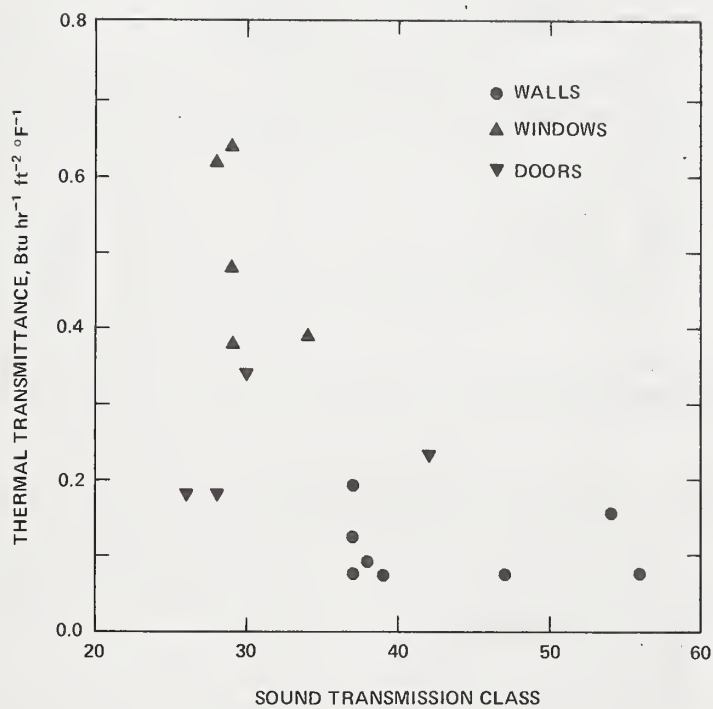
Figure 76. Comparison of Sound Transmission Class and thermal transmittance for basic walls, doors, and windows. The data plotted are listed in Table 6.
